Technical Memo

Project: US14A / US85 Deadwood Box Corridor Study

Subject: Existing Conditions

1.0 Introduction

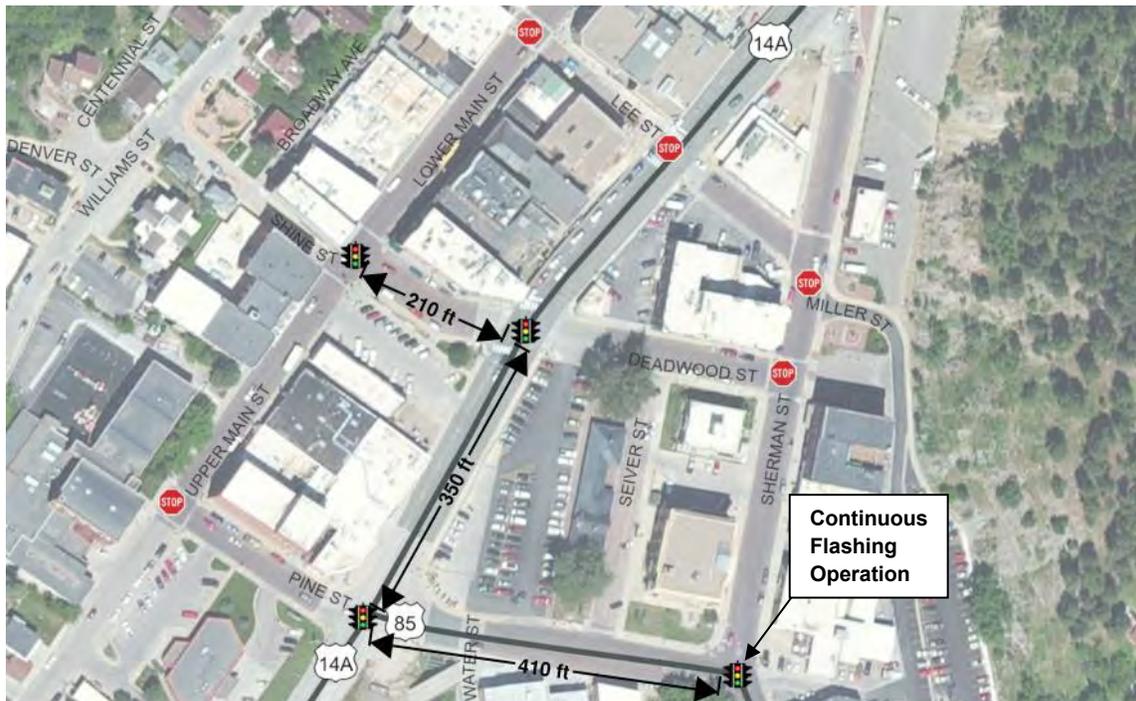
Figure 7. Spacing of Signals in Deadwood's Downtown Core

The proximity of four intersections within Deadwood's downtown core is shown in Figure 7. Figure 8 displays the all signalized intersections in the study area and whether the signalized intersections meet the spacing criteria listed in Table 1. Based on a signal spacing distance of one-quarter of a mile or 1320 feet, only one of the signalized intersections within the Study Area, the intersection of US14A and the northern junction with US85, meets the signal spacing distance criteria. The main reason for the closely spaced signalized intersections within the study area is due to limited space, the condensed nature of the Deadwood area, and the proximity of three parallel or somewhat parallel arterial corridors including Main Street (minor arterial), US14A / Pioneer Way (principal arterial), and Sherman Street (minor arterial). Historically, signals have been implemented in central business districts (CBD) to manage mobility and provide signalized pedestrian crossings. The signal density within Deadwood's downtown core isn't out of the norm for a downtown/CBD.

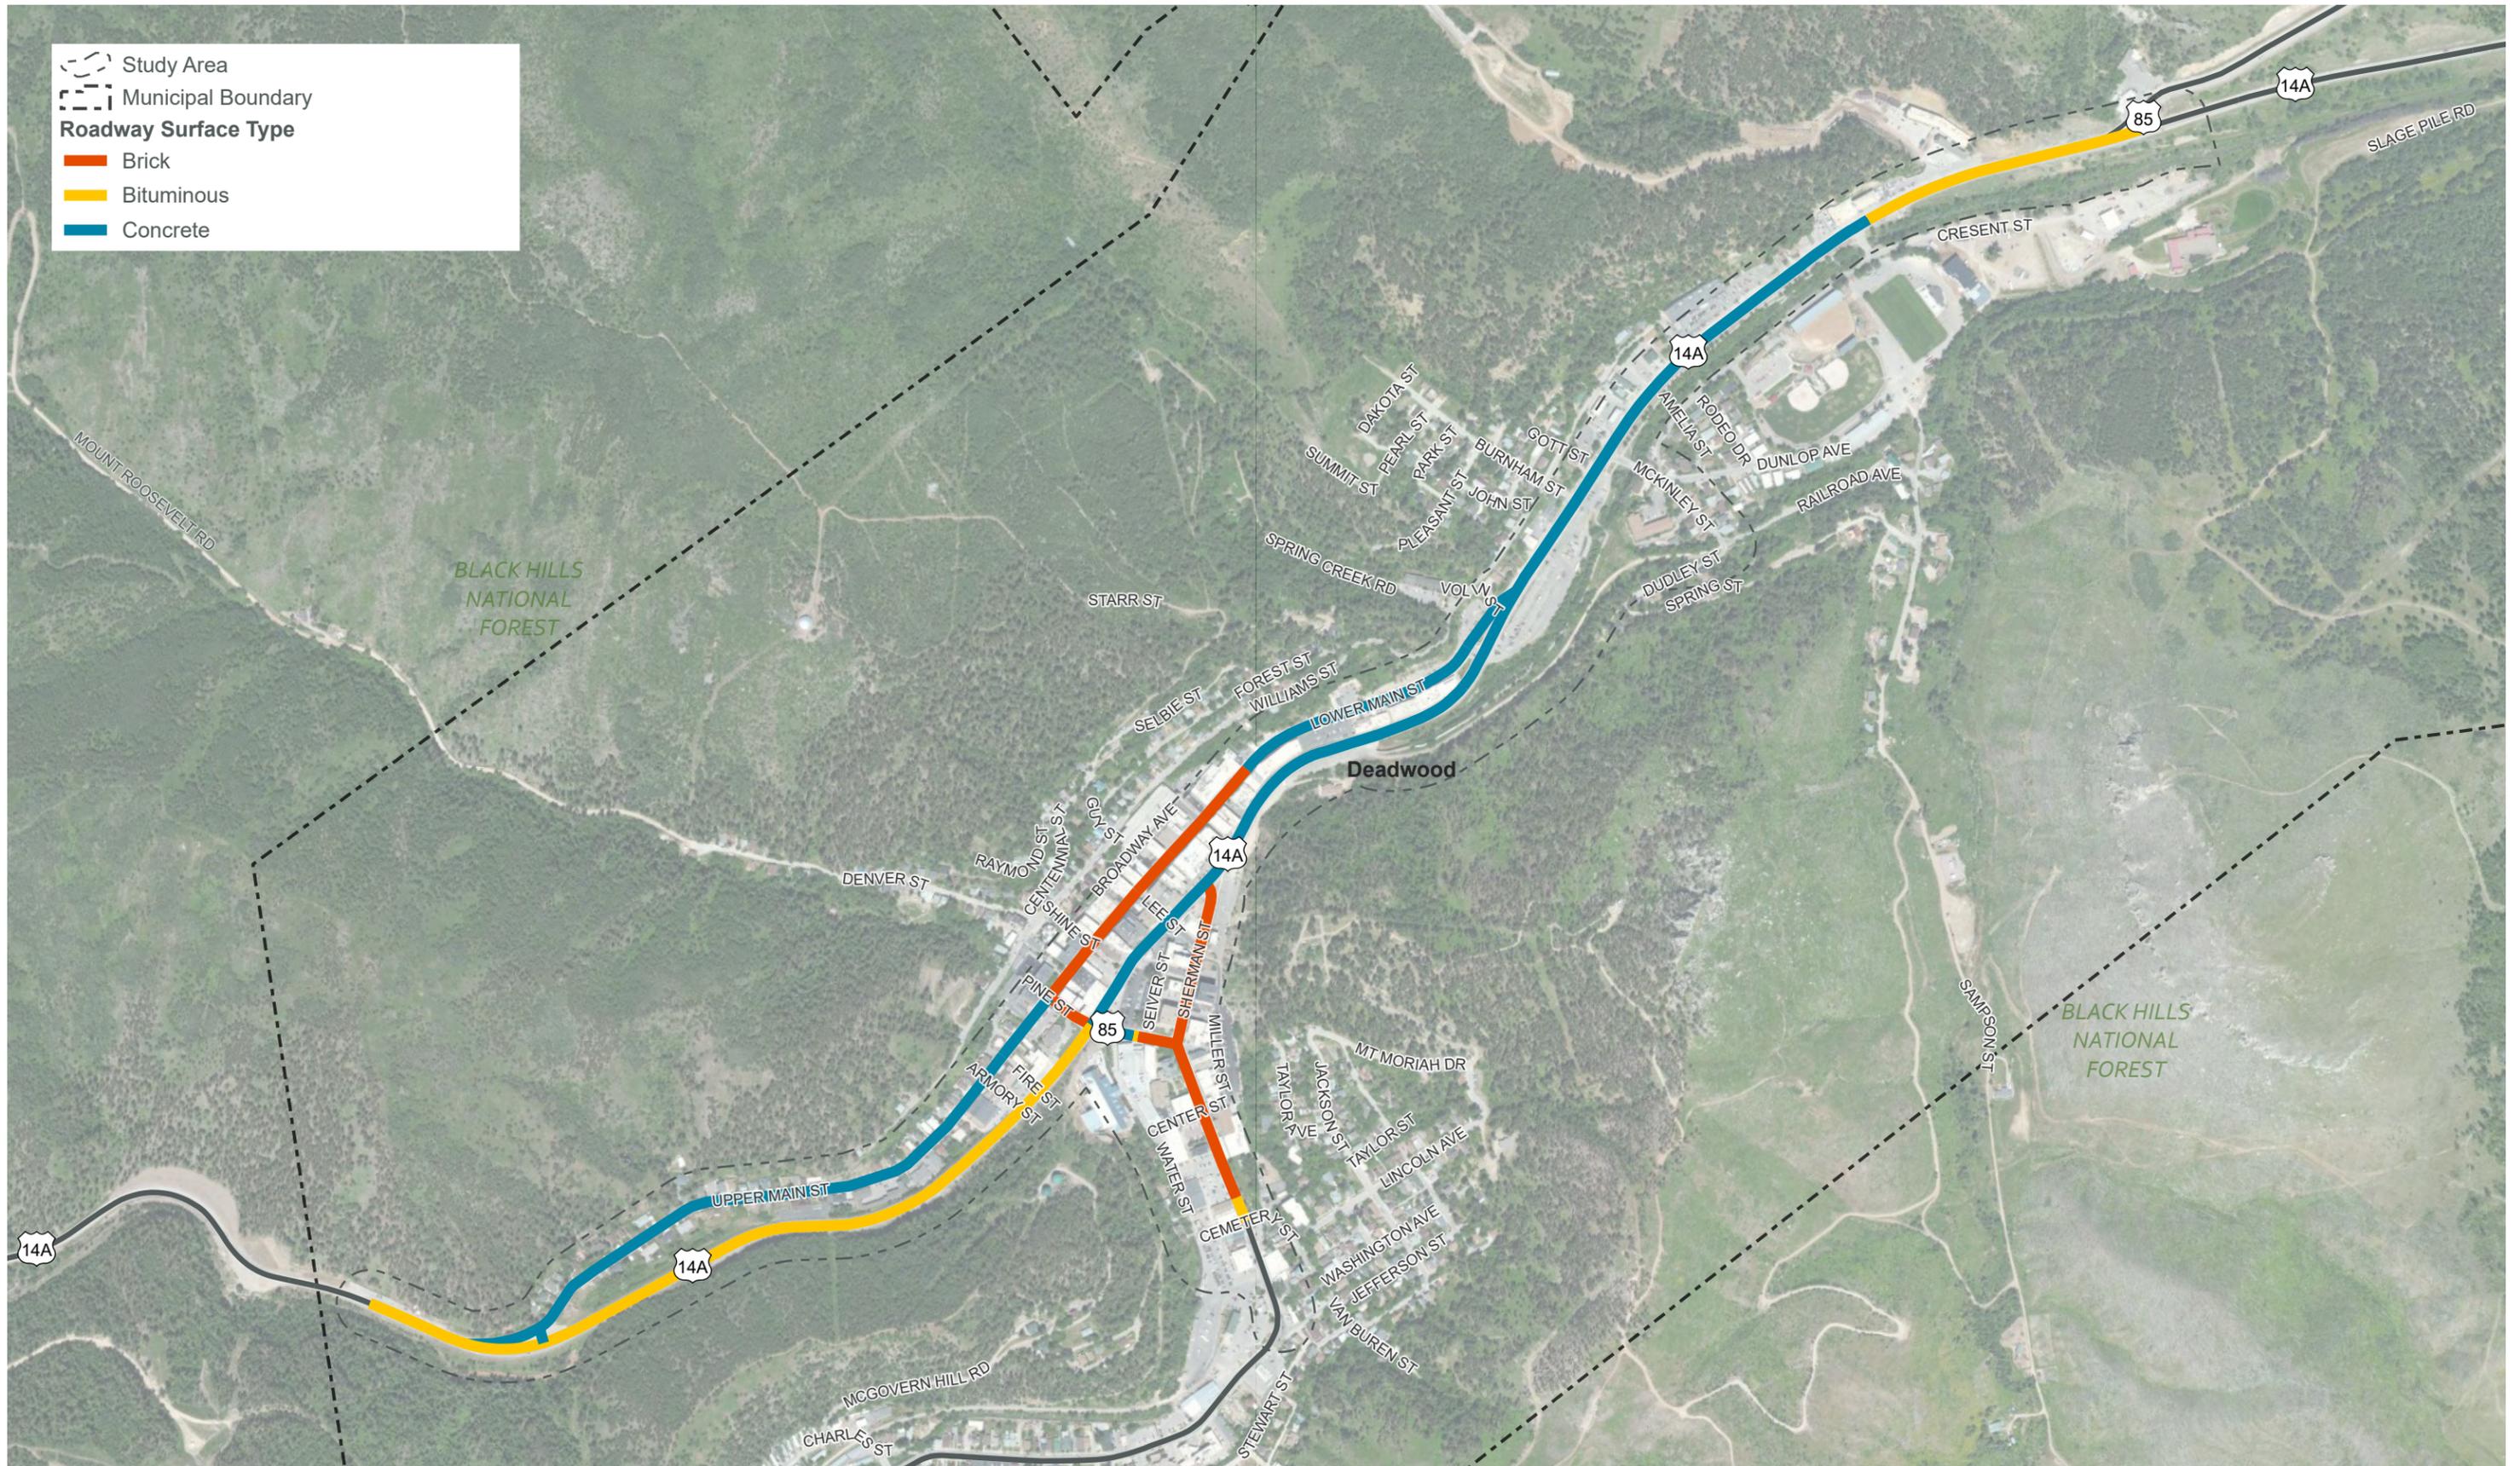
**ROADWAY SURFACE
 FIGURE 12**

As shown on Figure 12, Deadwood has a mixture of brick pavers, asphalt, and concrete as roadway surfacing. Brick pavers are prevalent throughout Deadwood to enhance the historic feel of the City. Brick is used on Main Street from Pine Street to Wall Street, Sherman Street from US14A to Cemetery Street, and the total length of Pine Street and some side streets within the study area. The remainder of the study area is paved with concrete or bituminous pavement.

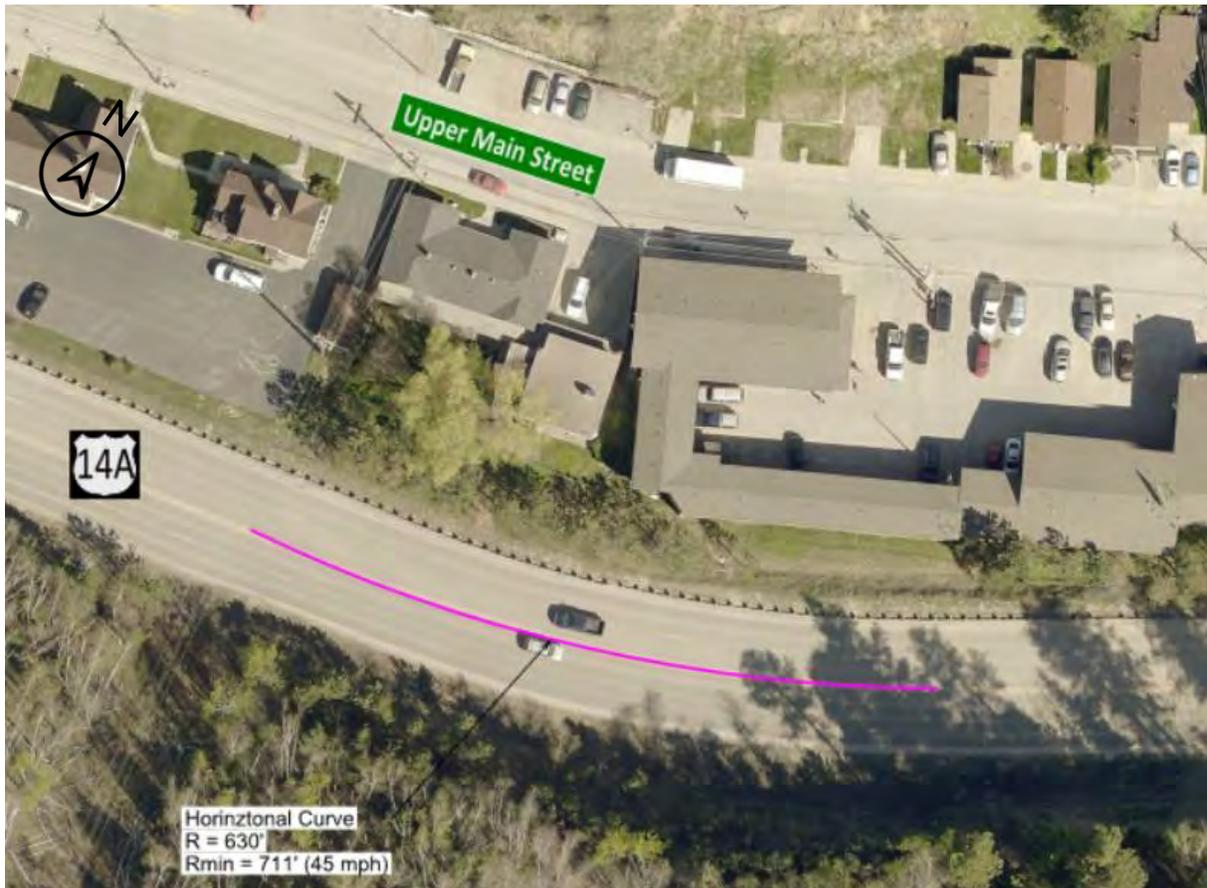
Figure 13. Horizontal Curve Review

The horizontal curve located along US14A to the south of the Gold Country Inn has a radius of 630 feet. The posted speed limit is 45 mph in this area. The minimum radius of a horizontal curve at 45 mph is 711 feet. The horizontal curve at this location has a radius less than the minimum radius required for a design speed of 45 mph. All other horizontal curves on US14A and US85 within the Study Area met or exceeded the minimum radius based on their respective design speeds. This horizontal curve segment experienced three crashes between 2015 and 2019. Based on the segment length and exposure, the crash rate of this curve is similar to nearby horizontal curves that meet design speed criteria. The curve's segment crash rate also does not exceed the study-wide averaged critical crash rate.

The horizontal curve on US14A to the south of Gold Country Inn has a radius less than the minimum radius for the design speed of the roadway segment. There are several intersections with inadequate intersection sight distance or a high amount of skew including US14A and Deadwood Street, US14A and Lee Street, US14A and Wall Street, US14A and Sherman Street, and US14A and Lower Main Street. This horizontal curve and intersections should be reviewed during the build concept phase to determine if correcting these geometrics are feasible.

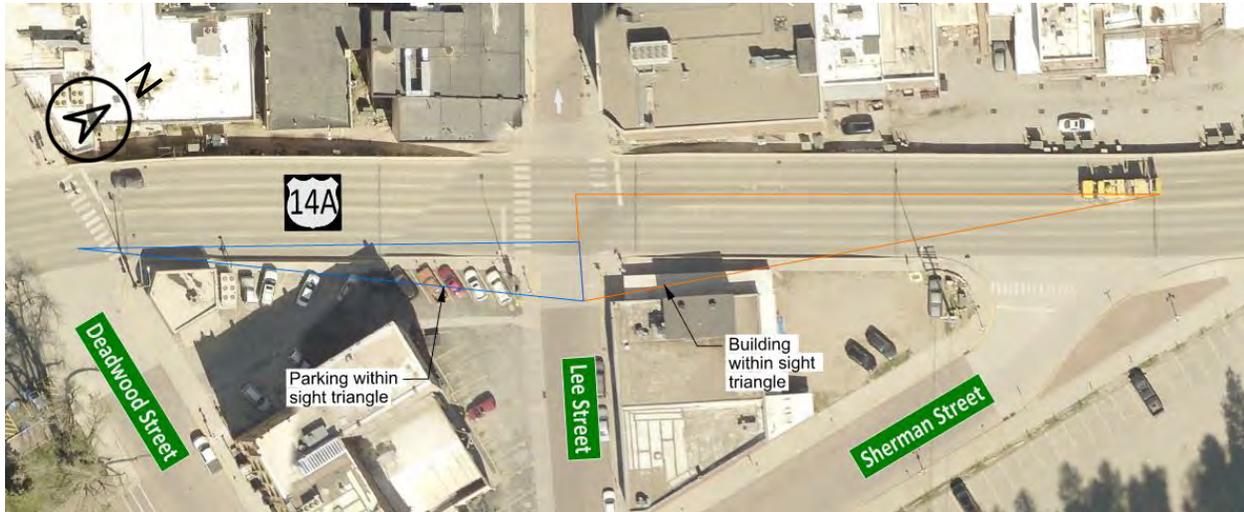
Figure 15. Intersection Geometrics at US14A and Lee Street

The intersection of Lee Street and US14A is located within the 25 mph speed limit zone and is unsignalized with two-way stop control from Lee Street. The west leg of Lee Street is a westbound one way street so the eastbound sight triangle from that leg is not applicable. The sight triangles are obstructed by parking within the southeast quadrant of the intersection and a building within the northeast quadrant of the intersection. If a vehicle travels forward beyond the stop bar and into the crosswalk and before the lane of the conflicting traveled way, a vehicle has adequate sight distance to complete the maneuvers previously listed. The crash history at this intersection did not indicate higher than average crash rates.

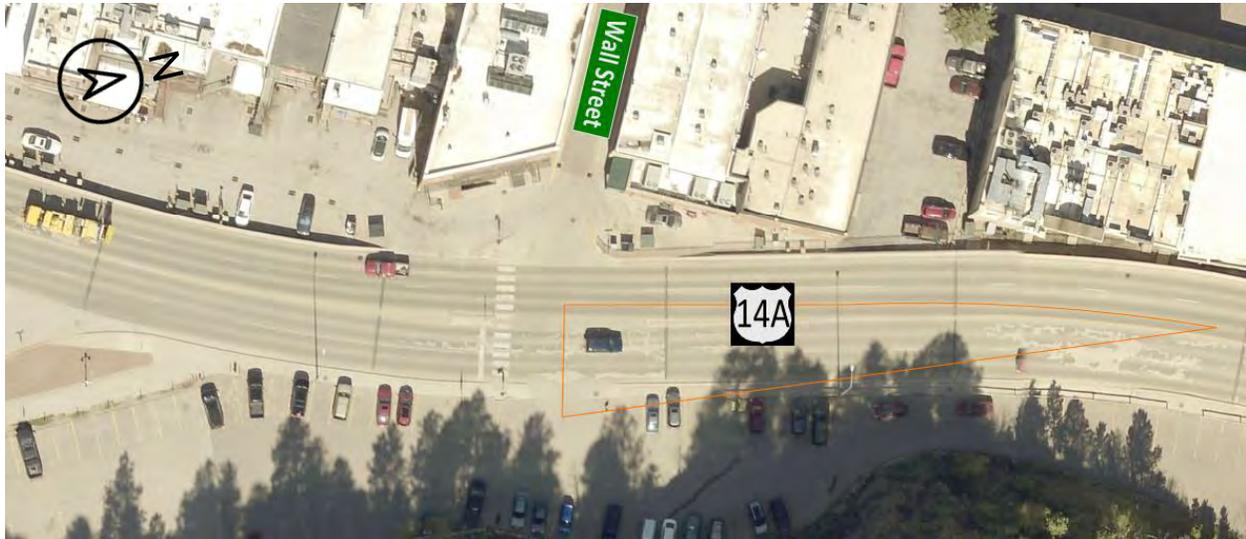
Figure 17. Intersection Geometrics at US14A and Wall Street

The intersection of Wall Street and US14A is located within the 25 mph speed limit zone and is unsignalized with stop control from the Parking Area across from Wall Street. The west leg of Wall Street is a westbound one way street so the eastbound sight triangle from that leg is not applicable. The sight triangle to the north is obstructed by parking within the northeast quadrant of the intersection. If a vehicle travels forward into the crosswalk and before the lane of the conflicting traveled way, a vehicle has adequate sight distance to complete the maneuver. As described in the *Crash History Review Memo*, this intersection experienced eight crashes between 2015 and 2019 and is one of two study intersections with a crash rate that exceeds the study-wide averaged critical crash rate.

During special events when Main Street is closed, the intersection of US14A and Wall Street becomes an all-way stop due to the high pedestrian volumes. This often causes traffic to back-up into the nearby signalized intersections of Deadwood Street and Lower Main Street.

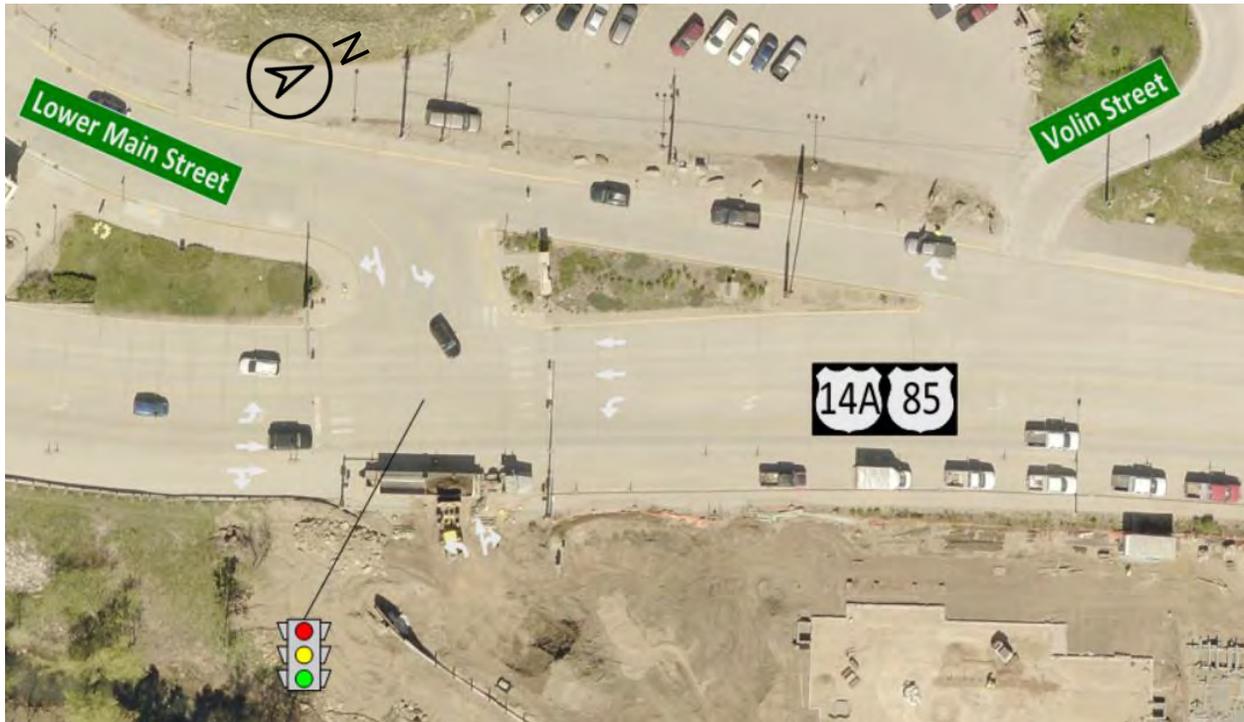
Figure 18. Intersection Geometrics at US14A and Lower Main Street

The intersection of Lower Main Street and US14A / Pioneer Way is atypical. Before US14A was built, Main Street was the thru movement with US 85 going through the downtown area. The construction of US14A required a retrofit situation with Lower Main Street, an intersection with a high amount of skew, and a slip ramp for southbound right turning traffic. The slip ramp maintains a direct inbound historic Main Street route/'gateway'. The approach angles for the eastbound left and right turns is less than optimal. However, the departure sight triangles for all turning maneuvers do not have obstructions within them. Volin Street intersects with the southbound right slip ramp and within the influence area of the intersection. The crash history at this intersection did not indicate higher than average crash rates.

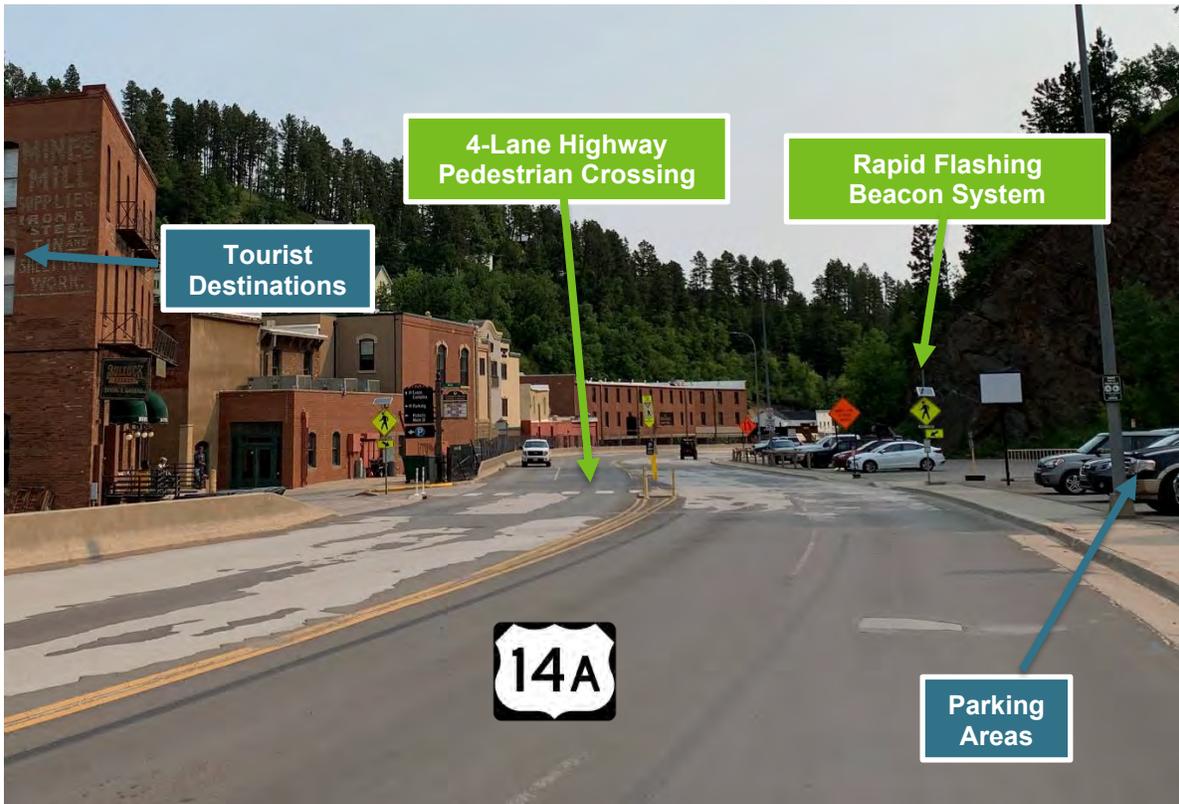
Figure 20. Crosswalk with Rapid Flashing Beacon across US14A at Wall Street

Pedestrian facilities through town include curbside sidewalks of varying widths, as shown in Figure 24. There are cross walks at signalized intersections and unsignalized intersections with pedestrian-actuated rapid flashing beacons at popular crossing locations. There are two main unsignalized crosswalks across US14A including one at Wall Street, as shown in Figure 20, and one at Lee Street. The City has received several complaints about these crosswalks over the years. The 2008 Deadwood Pedestrian Circulation and Enhancement Study cited that pedestrians were unlikely to use the buttons that actuate the rapid flashing beacons. In addition, the distance of the crosswalk, the speed at which traffic was traveling on US14A and the volume of traffic were intimidating to pedestrians that need to cross. The demographics of pedestrians is widely varied from families to older generations and proposed designs should accommodate a variety of walking speeds.

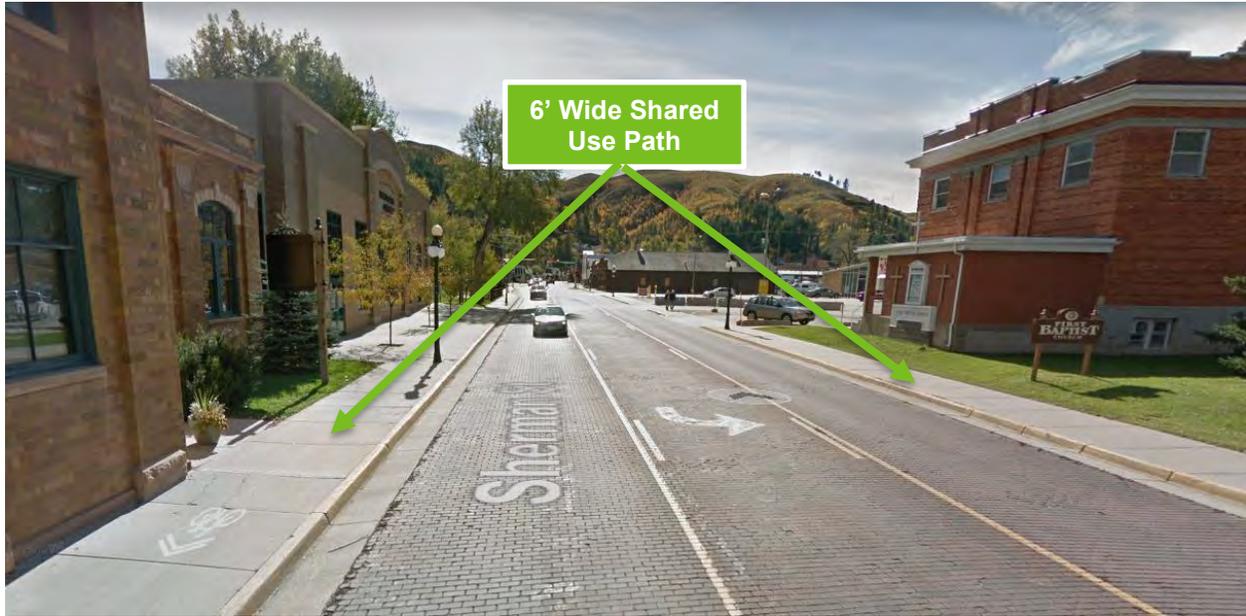
Figure 21. Shared Use Path Designation on Sherman Street's Sidewalks (Facing South)

The multi-use paths and trails are shown in Figure 24 along with plans for future expansions of the trail systems. Currently, the trails are not connected with shared-use facilities that are wide enough to accommodate both pedestrian and bicycle traffic. Sidewalks 6 feet or less along both sides of Sherman Street and the east side of US14A serve as the network connections between the recreational trails. The sidewalks along Sherman Street are currently striped and signed as bicycle routes, even though they do not meet width requirements, and are heavily utilized by bicyclists making the connection between the Mickelson Trail and Whitewood Creek Trail. The 6 foot sidewalk along the east side of US14A has signage for bicyclists to dismount due to the narrow sidewalk, light poles, and frequent pedestrian usage.

There is a need for a 10 foot wide shared use sidewalk between the Mickelson Trailhead and the Whitewood Creek Trailhead. With the future plans for expansion of the Whitewood Creek Trail, the lack of a shared use path along Sherman Street and US14A is a missing link for the potential northern expansion of the Michelson Trail system to Sturgis or Whitewood.

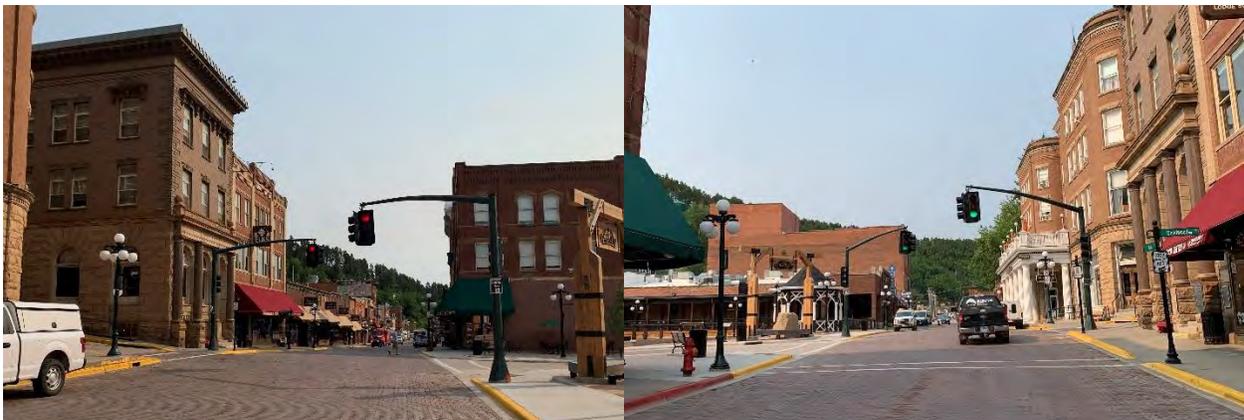
**Figure 23. Signalized Intersection at Main Street and Deadwood Street/Shine Street
Looking North (Left Photograph), Looking South (Right Photograph)**

The current intersection of Main Street and Deadwood Street / Shine Street does not include pedestrian signal heads with countdown timers. Recent improvements to this intersection line up the previously offset streets of Deadwood Street and Shine Street. Although not a main study intersection, the City may want to have this signal reviewed for meeting warrants. Based on conversations with the City, there have been several close calls between pedestrians and vehicles. Although, zero pedestrian-vehicle crashes were reported to the state in the past 5-years. Pedestrians may tend to ignore the signal indications due to the absence of pedestrian signal heads and the lack of traffic on Shine Street. Vehicles heading eastbound on Shine Street see the green indication and may assume it is safe to proceed. Inadequate sight distance due to building corners block the view to see some of the pedestrian movements.
